Slips trips and falls in the Dairy Farming Sector

Dave Moore¹, David Tappin, Liz Ashby and Richard Parker - COHFE
Tim Bentley - Massey University

Introduction

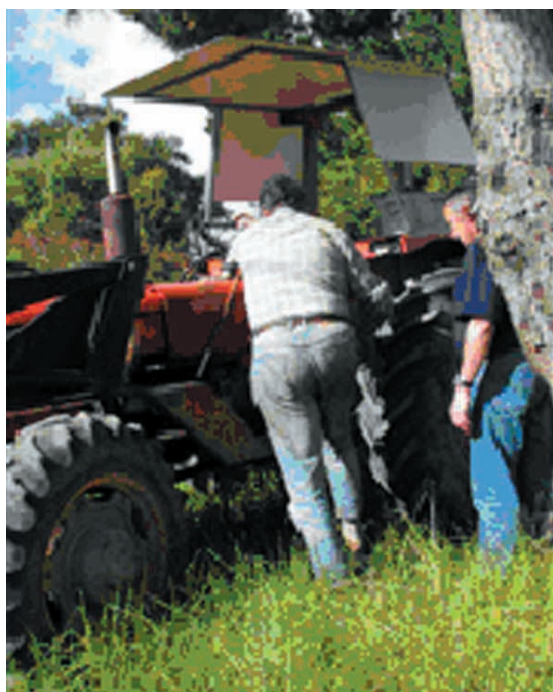
Figure 1. Observing the site of an injury event

The main methodology for this research phase was detailed STF incident follow-up investigations, involving a detailed face-to-face semi-structured interview with the injured worker, site observations, plus photographic evidence where needed.

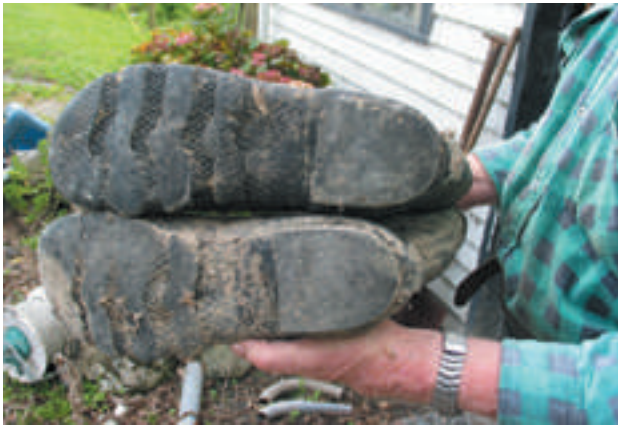
Figure 2. Worn boots

- Rushing (usually running or turning fast)
- Divided attention (distraction away from watching where feet are being placed)
- Use of worn footwear or footwear unsuitable for the surface characteristics (Figure 2)
- Plant or equipment design factors (e.g. steps built with inconsistent geometry of risers and/or tread depth).

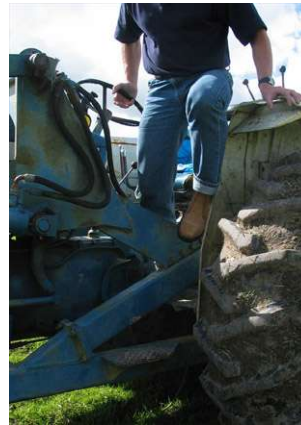
Figure 3. Trip hazards introduced where a fore-end loader has been added.

Guidance is needed on good design of systems (footplates, handholds) for access/egress, mounting or alighting from tractors and other large pieces of plant. This is of particular importance for those retrofitting machines with new devices such as fore-end loaders as the original means of access will get obstructed and potentially made far more hazardous. The case study below relates to this.

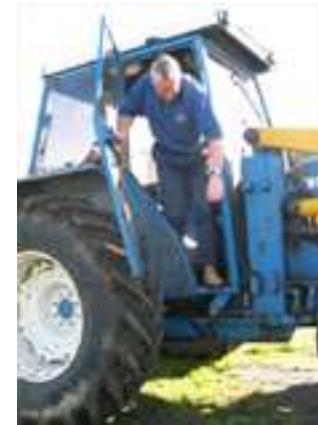
Figure 4. Trip hazards are common when using the right hand door of a tractor - especially for wearers of overtrousers.

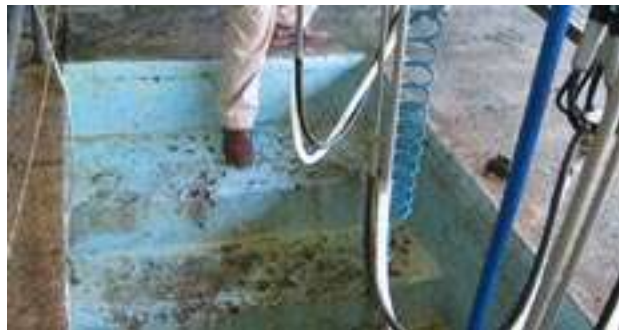
Figure 5. Concrete pit steps with generous tread dimensions are good for gumboots.

<p>Step classification Steps around sheds are currently classed as Service Stairs, which can be steeper than steps generally found in outdoor areas by people moving at speed in muddy boots public (compare metal steps in Figure 6). This encourages dairy shed workers to jump down the steps. The classification used by the Building Inspectorate should be changed.</p>	
<p>Nosings and riser heights Tripping over aprons or nosings when going up is common as the stairs are often too steep (see above). To make this worse, the top step is often up to 50mm higher than the others as a nib as added for surface water control. Riser heights should be kept to a minimum acceptable level to provide shallow flights.</p>	
<p>One-person operation Milking shed systems need to be designed to make solo operations smoother - minimising the need to rush. Good new and retrofit designs should be promoted.</p>	<p>Figure 6. All three treads on this flight are different sizes. In descent, only the heel would fit on the bottom two steps.</p>
