Response of a stream ecosystem to debris flows

A case study following the recovery of a recently harvested headwater riparian and stream ecosystems after extreme rain, flooding and debris flows.

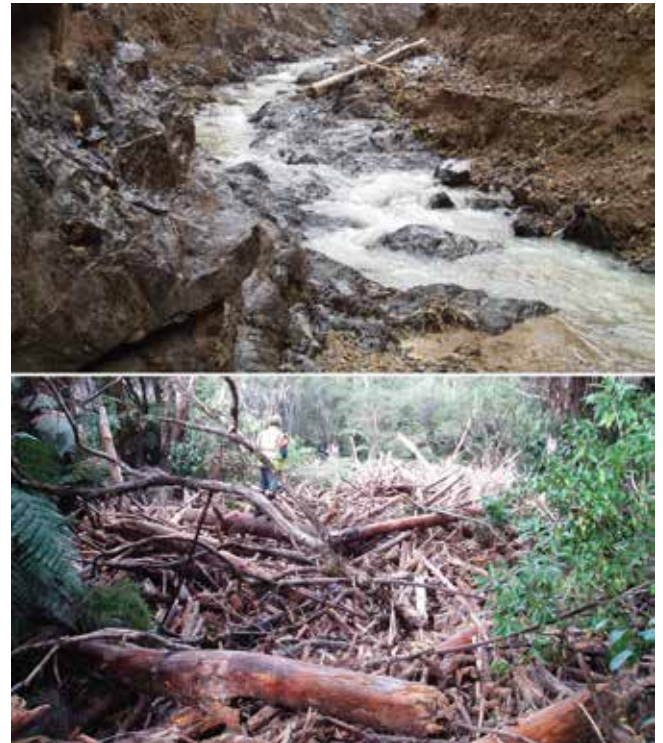
Debris flows scour out headwater stream channels (top) and depositing the material downstream (bottom).

Steeply planted forests on erodible geologies and soils are particularly vulnerable to these events during harvest and in the immediate post-harvest phase. This is due to the larger quantities of more mobile logging slash, loss of roots to hold the soil and lack of protective standing vegetation on the hillslopes. Intense rainfall events can initiate landslides containing large quantities of sediment, water and wood that transform into debris flows when they reach the stream channel.

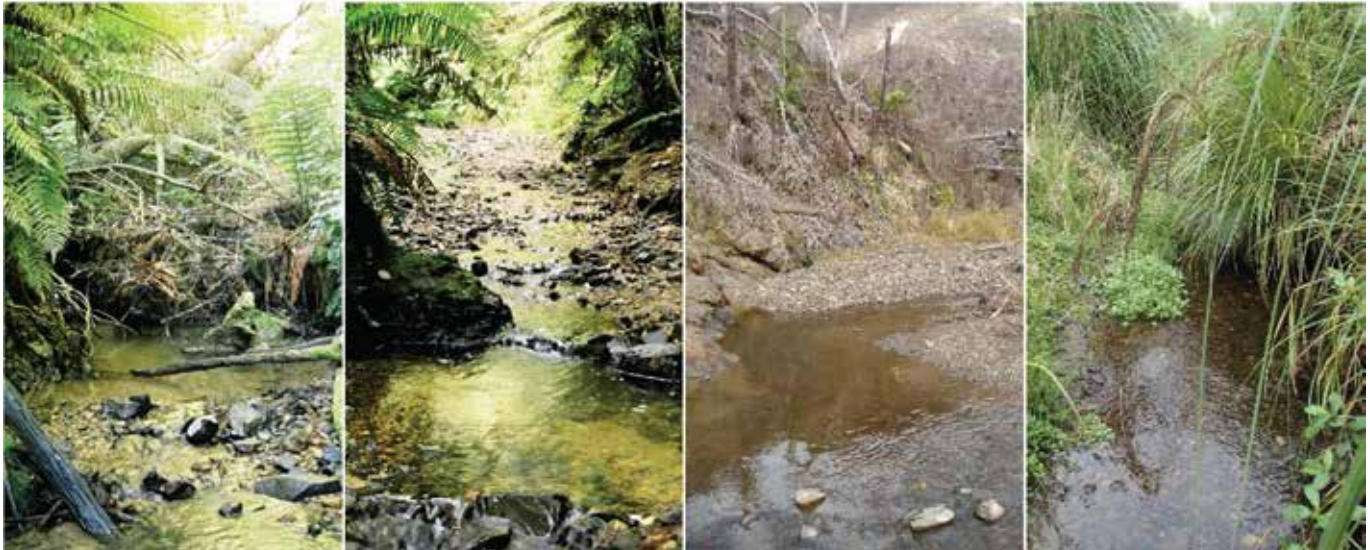
Pool habitat before harvesting and the extreme weather event.

Pool habitat immediately after the event and five years later.

The scouring effect of debris flows also reduced the number of pools, including nearly all the pools formed by stable wood in the streams. The number of pools recovered to varying degrees in the first five years. Although pools formed by wood were scarce, some in-stream and overhead cover was provided by the reestablishing riparian vegetation.

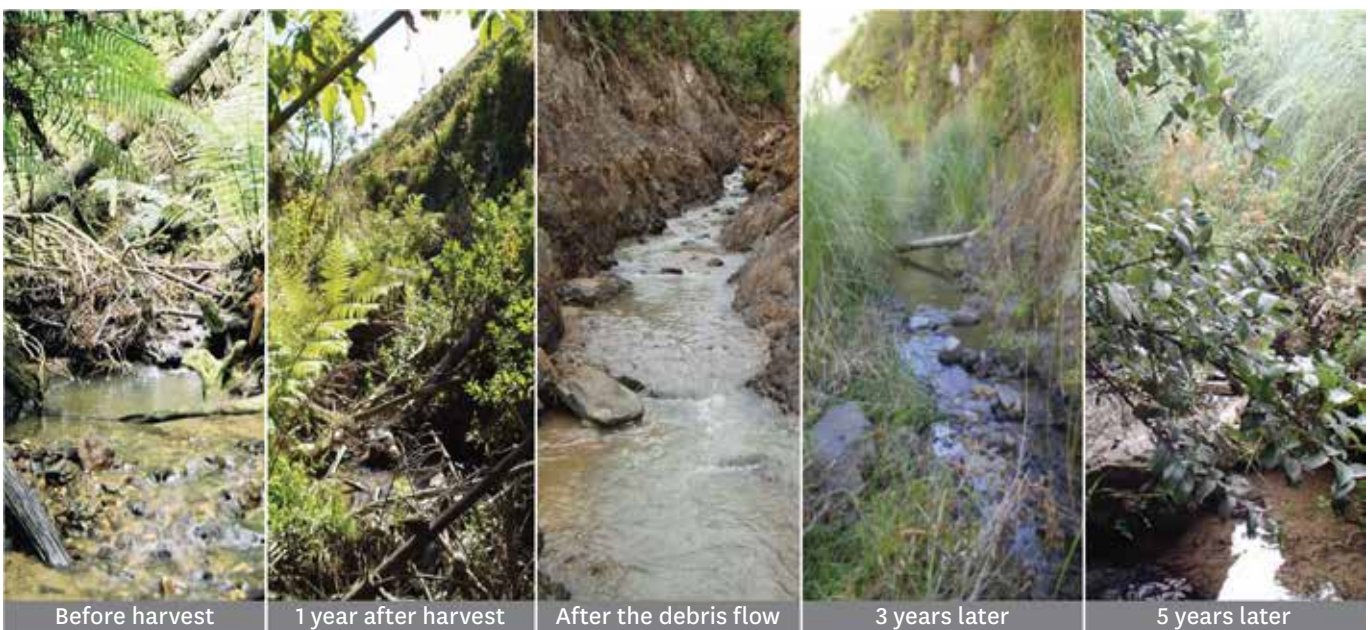
Before harvest

1 year after harvest

After the debris flow

3 years later

5 years later

The overhead cover and shade provided by the recovering riparian vegetation was a key factor influencing in-stream recovery.

The debris flows removed any shade provided by the riparian vegetation remaining after harvest and woody debris exposing the stream channels to increased levels of sunlight. Water temperatures warmed initially, then gradually declined as the height and density of the recovering riparian vegetation increased, shading the stream channel. Algae was prevalent in the streams in the first few years.

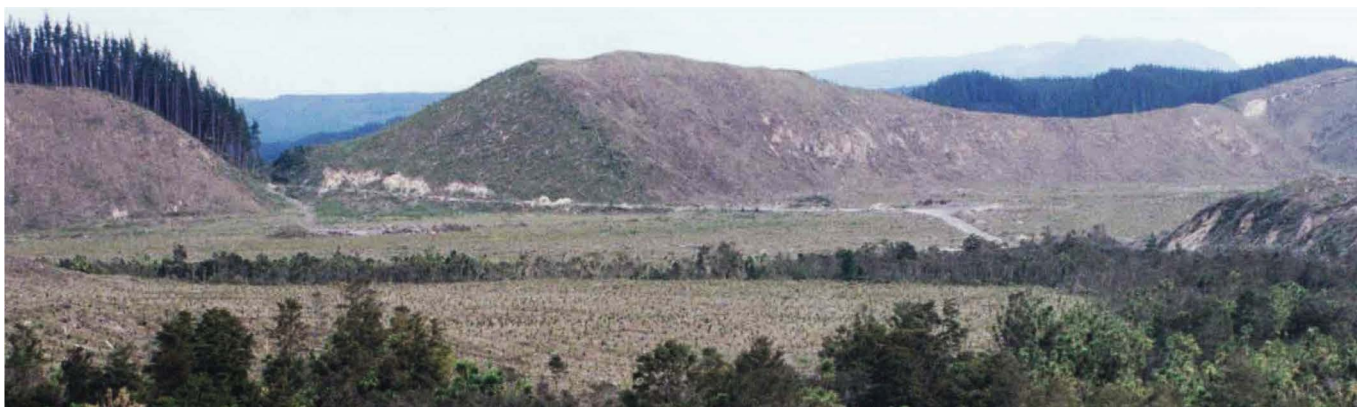
Retention of an intact riparian margin during and after harvesting.

- Minimise the amount of logging slash entering streams during harvest (Forest Practice Guide).
- Facilitate riparian recovery as the shade it provides has a strong impact on stream recovery rates.
- Maintain current practices for herbicide application that include a 'no herbicide' zone along stream margins to protect recovering riparian vegetation.
- In sites with available wood supply and machine access, there is the potential for the re-introduction and strategic placement of large stable pieces of wood (see Wood in Streams).
- Retain intact riparian forested margins to provide shade, habitat and a long-term source of wood and leaf litter to streams.
